DESTROYER ENGINEERED OPERATING CYCLE (DDEOC)

System Maintenance Analysis
FF-1052 CLASS ASROC LAUNCHING GROUP

REVIEW OF EXPERIENCE

October 1976

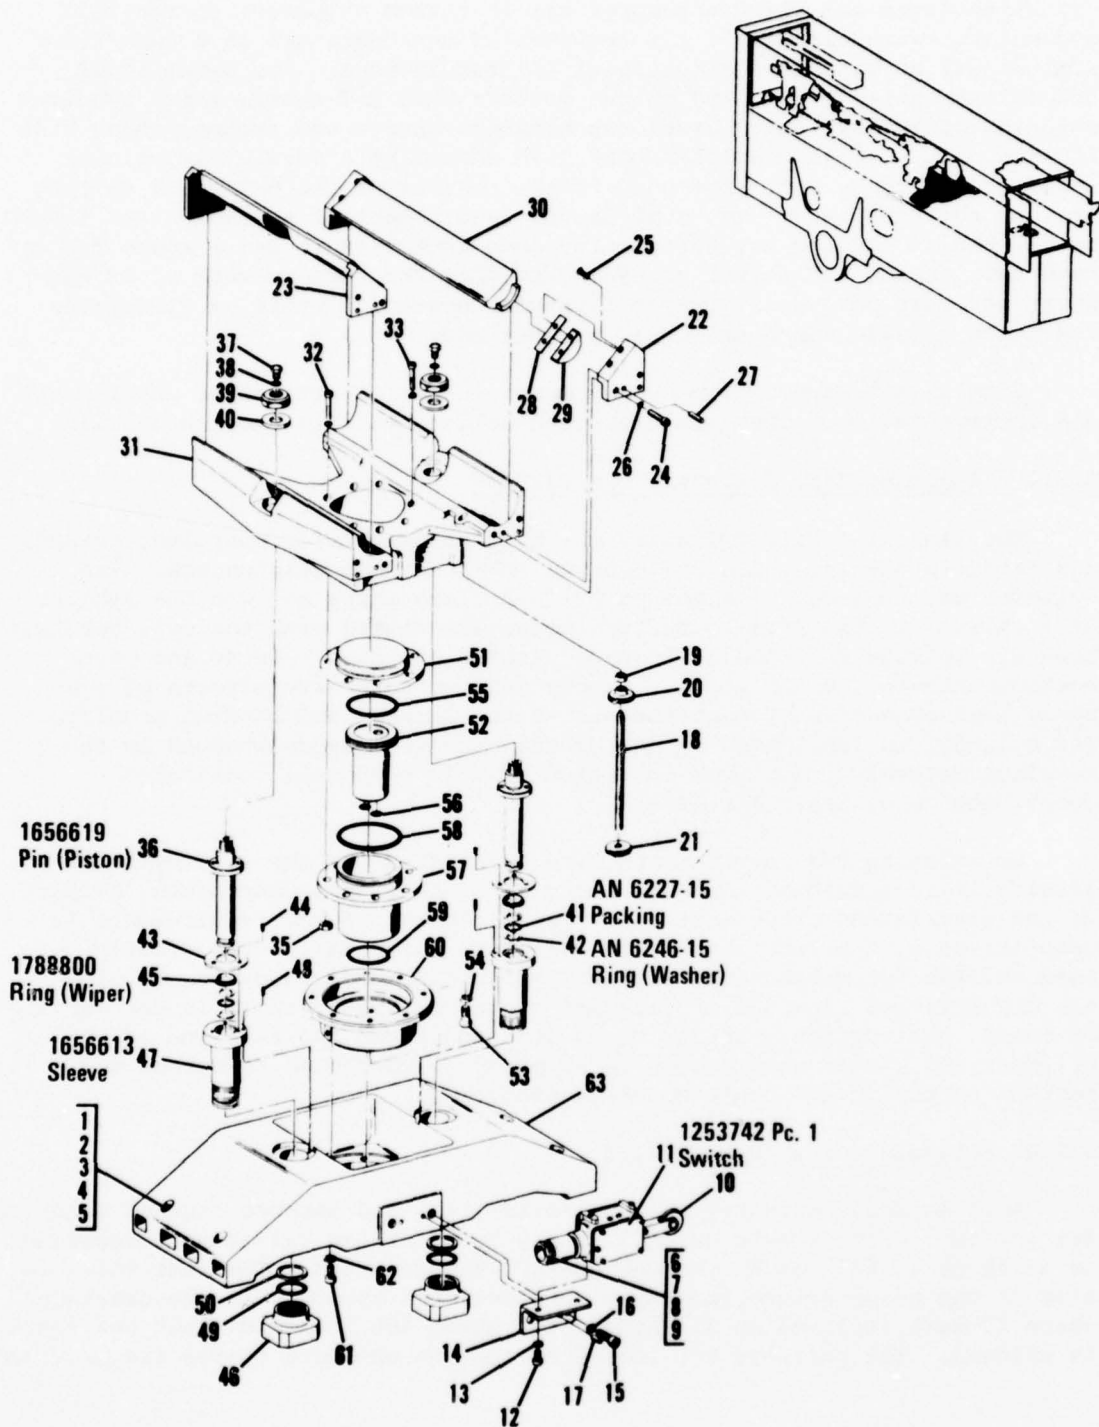
Figure 3-1. SNUBBER ASSEMBLY, BOTTOM FORWARD, P/N 1807541

Eighteen (49 percent) of the 37 guide CASREPTs* were attributed to the bottom snubbers. The summary of frequently used parts for the guide revealed that the entire bottom aft snubber was replaced 26 times by 7 ships at a cost of \$2280 per snubber, and the bottom forward snubber assembly 18 times by 3 ships at \$2540 per replacement. Several snubber parts have also shown high usage. For ease of reference, an annotated reprint from the ASROC IPB is included as Figure 3-1 to illustrate these parts.

The most common failure mode associated with the snubbers is the inability to fully extend or retract them due to binding between the hydraulic pistons (No. 36 on Figure 3-1) and sleeves (No. 47 on Figure 3-1). When the cell is loaded and the snubbers extended, the pistons are also extended out of the sleeve. In this position they are exposed to the corrosive effects of salt air and sea water entering the cell via the non-watertight cell doors. The piston on the aft snubber was reported replaced 98 times by 16 ships; the forward piston 36 times on 13 ships; the sleeve (which is common to forward and aft snubbers) 110 times by 21 ships; and the associated packing, wipers, and washers many times on several ships. Fleet interviews confirmed this failure mode, as did discussions with NAVSEA technical personnel, who also reported some problems with piston manufacturing quality assurance. (Omission of one wiper was a quality assurance problem.) Compounding these problems is the inaccessibility to the snubbers for corrective maintenance when a cell is loaded.

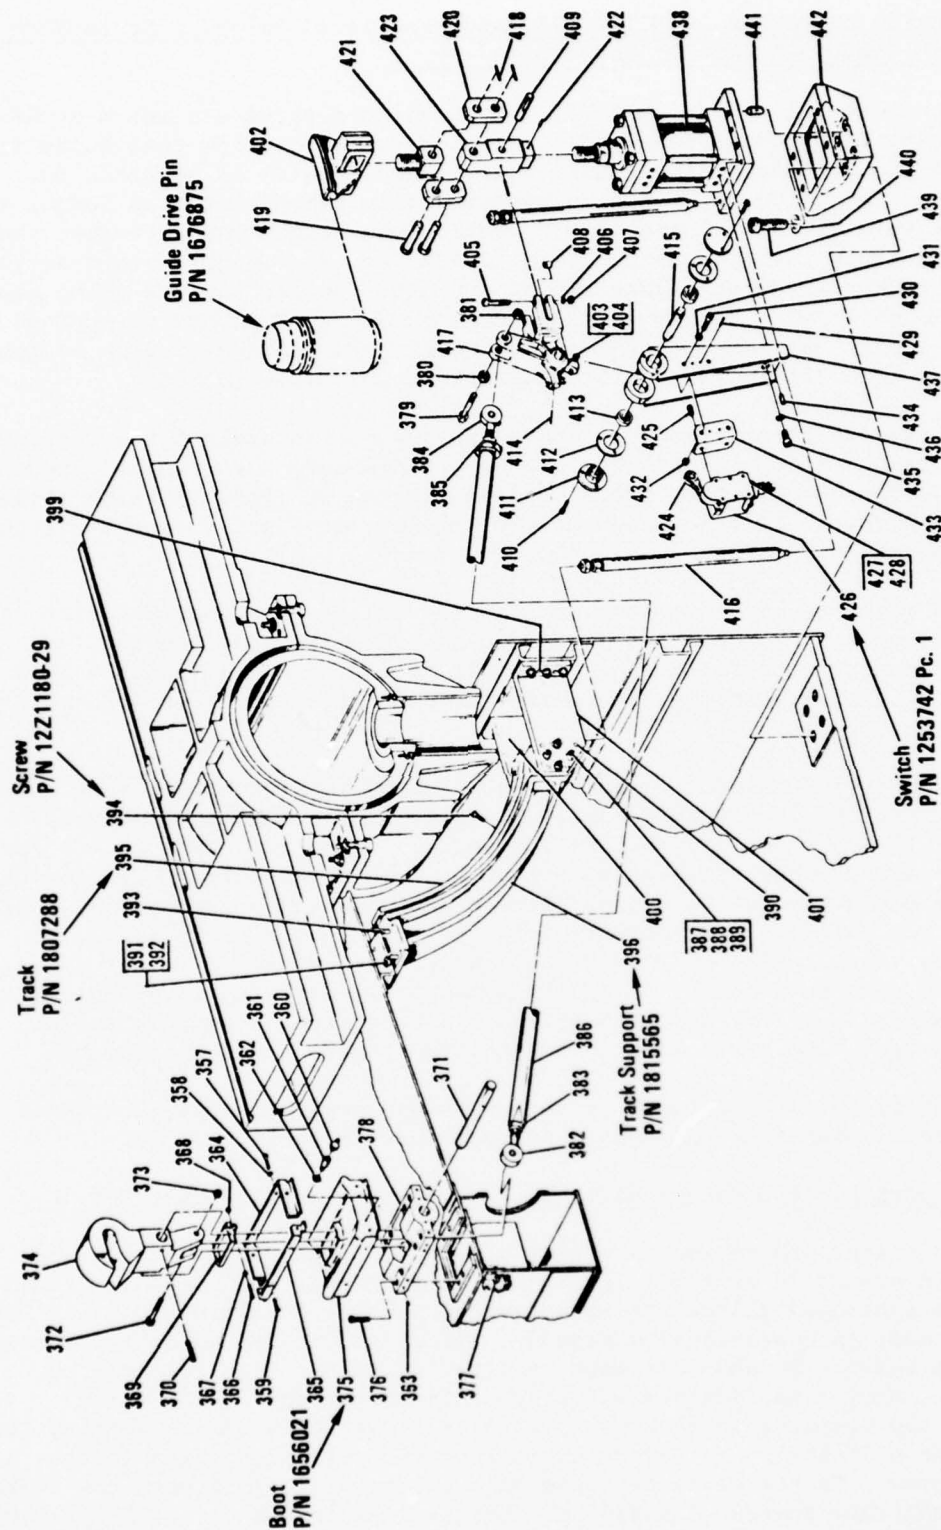
Figure 3-2. GUIDE DRIVE PIN ASSEMBLY

The most frequent symptoms of problems in this assembly are binding and misalignment of the guide drive pin due to corrosion, scoring, and lack of lubrication. The failure modes resulting from this malfunction include sheared tracks, broken track supports, cracked stiffeners, and broken drive-pin mounting bases.

The boot, P/N 1656021, which is also shown in Figure 3-2, is a protective device installed in the guide-drive-pin/elevation-stow-latch assembly. A total of 120 were replaced on FF-1052 ships. These replacements are due to normal wear and tear and weather exposure. Fleet interviews also indicated that the boots for guides 2 and 3 were often damaged by removal and replacement of the carriage enclosure's center panel. This problem should be solved by installation of ORDALT 7695, which includes a different center panel and personnel access door arrangement. The sparing level specified on the APL (i.e., four on-board spares) is considered adequate, and no extended operating cycle maintenance-related problems are anticipated.

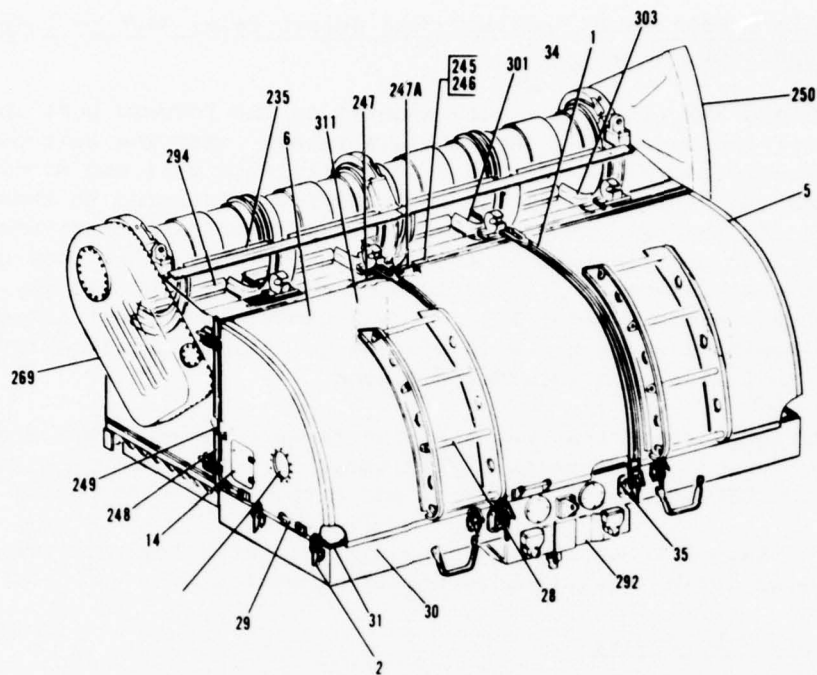
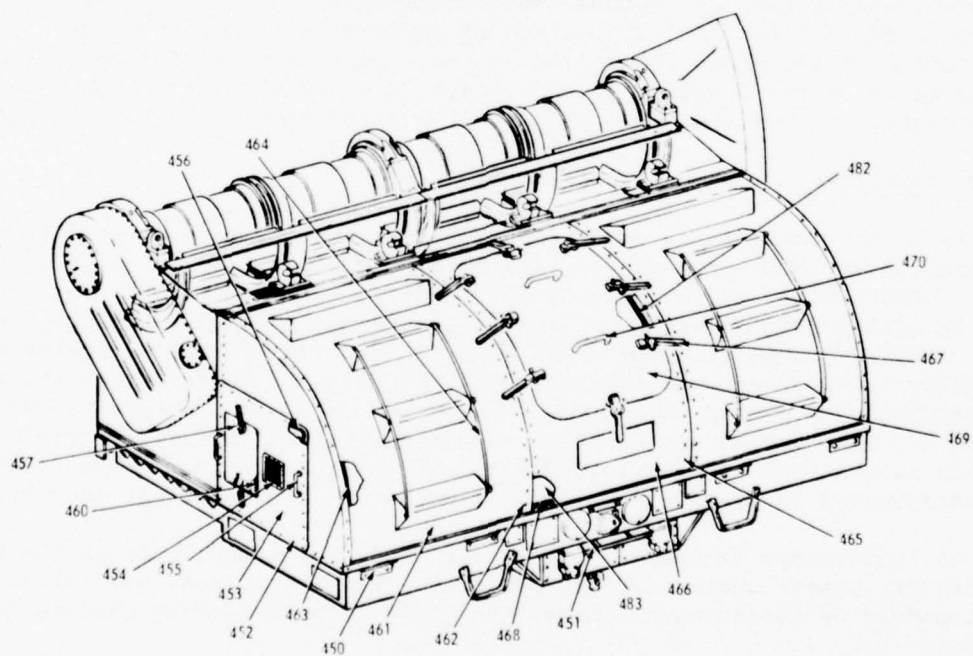
Figure 3-3. CARRIAGE SHIELD BEFORE AND AFTER ORDALT 7695

As in the case of the guide, several improvements to the carriage and its associated components are in various stages of development or installation. ORDALT 8105, which was discussed under guide improvements (Section 3.2.11), also provided gasket material for carriage enclosures as an interim fix. ORDALT 7695 is a follow-on to 8105, it provides for major improvements, including a new fiberglass carriage shield to prevent water entry into the carriage and to prevent gun-blast and wave damage to the launcher carriage. Figure 3-3 illustrates the carriage appearance before and after installation of this alteration. The estimated kit cost for this alteration is \$10,000, and anticipated IMA/yard installation time is 144 man-hours per launcher.

An improvement to ORDALT 7695 is currently being developed at the Naval Underwater Systems Center (NUSC), Newport. This improvement will alter the front panels by replacing the more than 90 bolts with dogging closure devices.
